EARTHQUAKES AND BUILDING CONSTRUCTION

A Review of
Authoritative Engineering Data
and Records of
Experience

Published by CLAY PRODUCTS INSTITUTE OF CALIFORNIA
611 Architects Bldg., Los Angeles 116 Natoma Street, San Francisco

COPYRIGHT 1929 BY CLAY PRODUCTS INSTITUTE OF CALIFORNIA

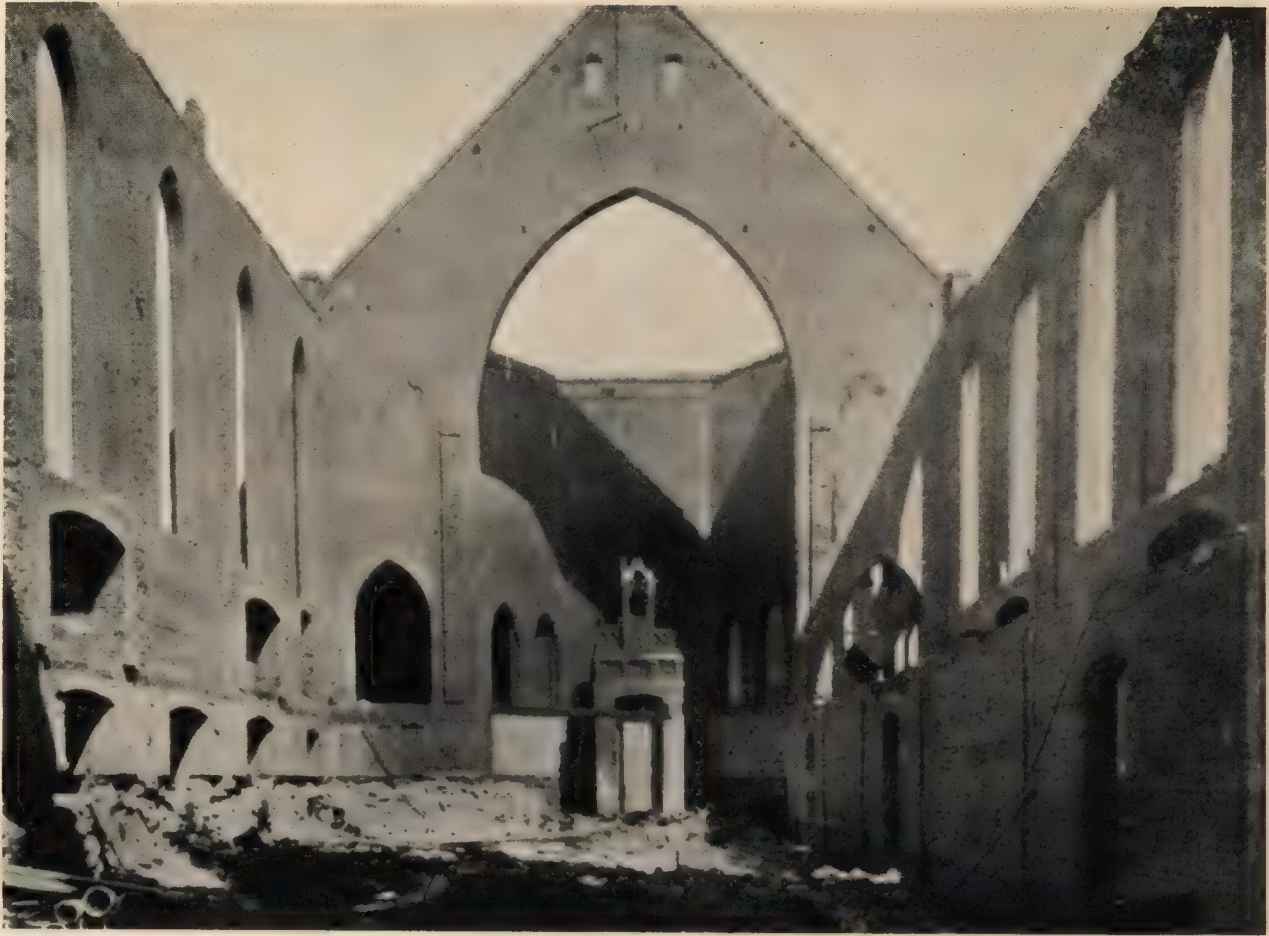
No. 27—Interior of Saint Francis Church, built in the early 50's. Note particularly stability of very lofty walls. In use 1929.

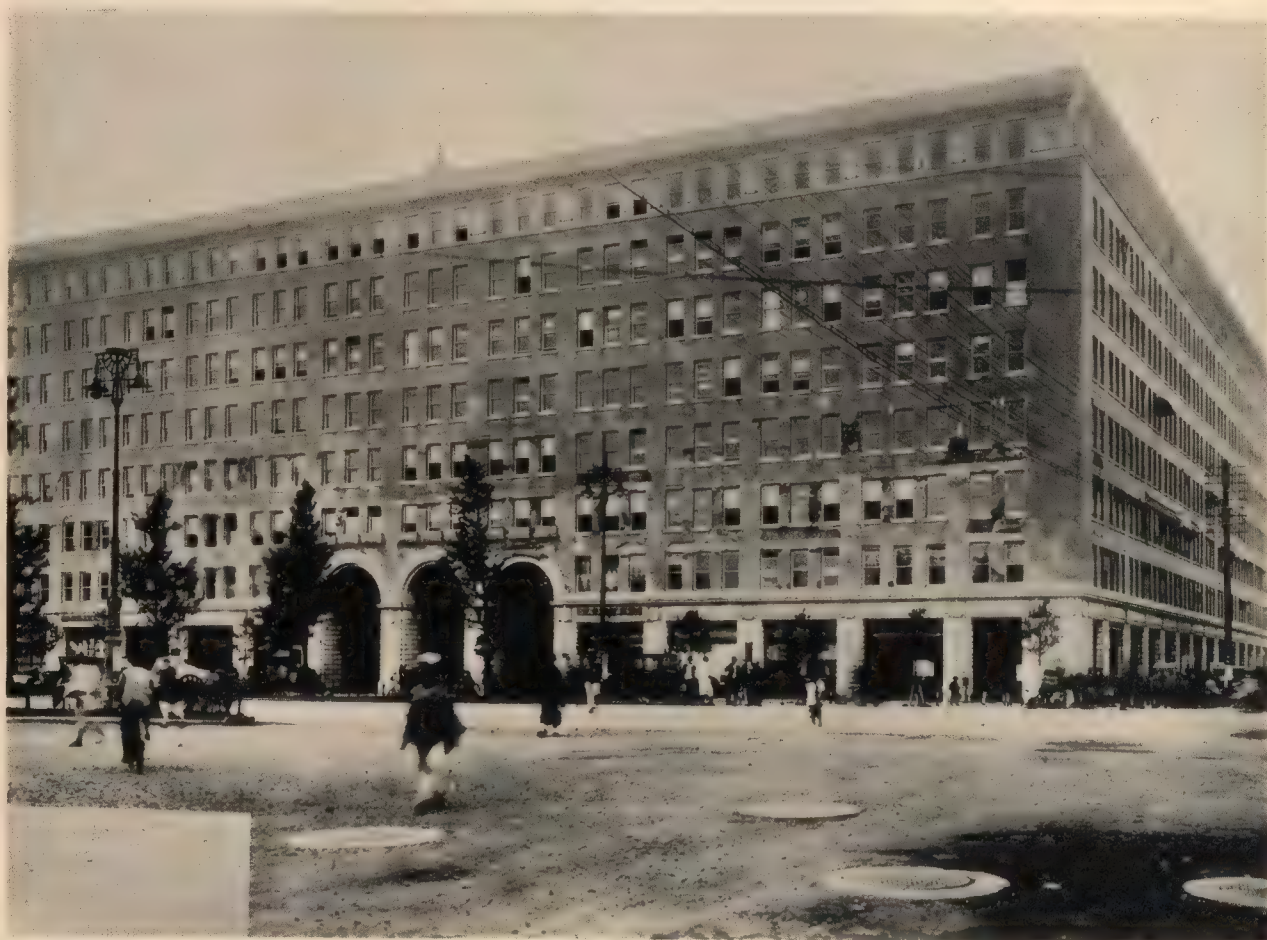
No. 32—Marunouchi Building, steel frame, brick curtain walls, terra cotta trim. One of the largest buildings in Japan, showing condition immediately after earthquake.

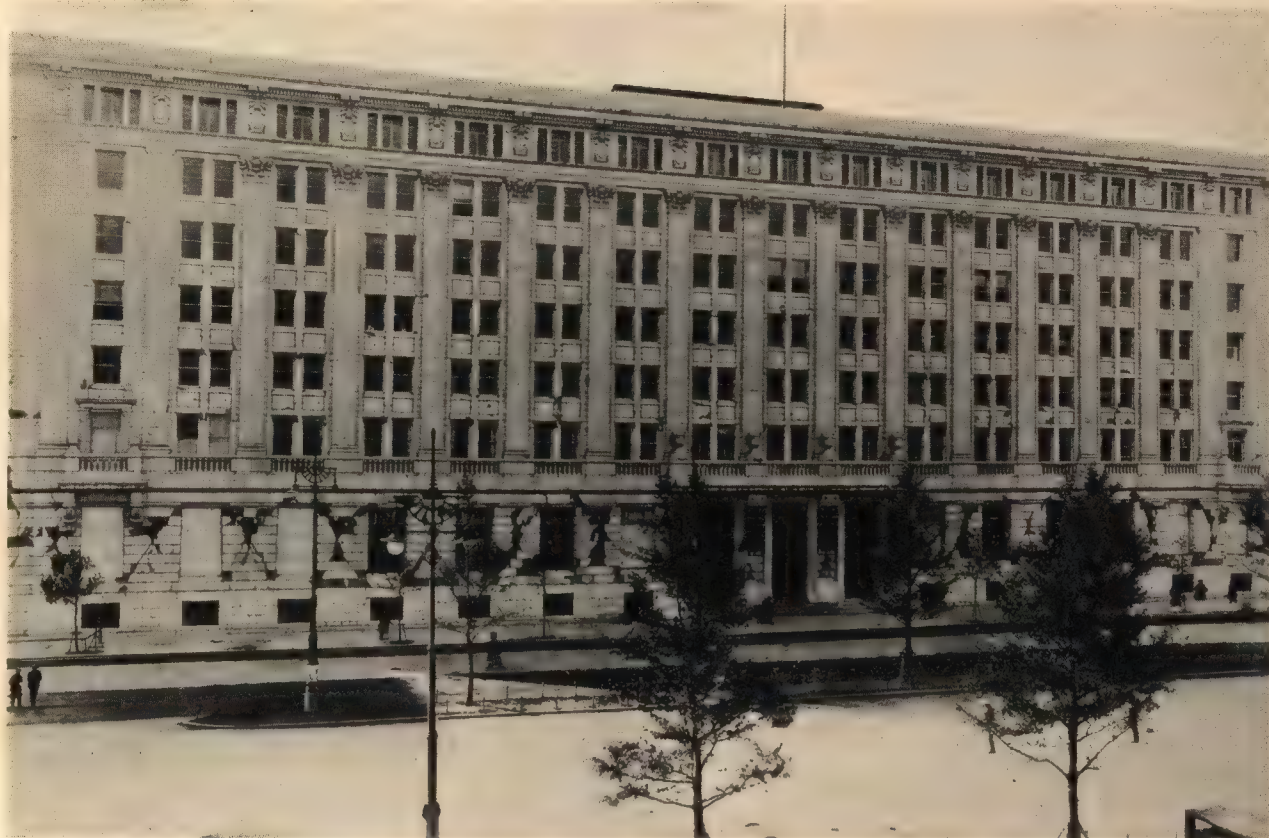
No. 33—N. Y. K. or Yusen Building. Steel frame, brick filler walls, terra cotta trim. Condition shortly after quake. Note diagonal cracks in first floor walls. Damage to building less than 10% of value. In use 1929.

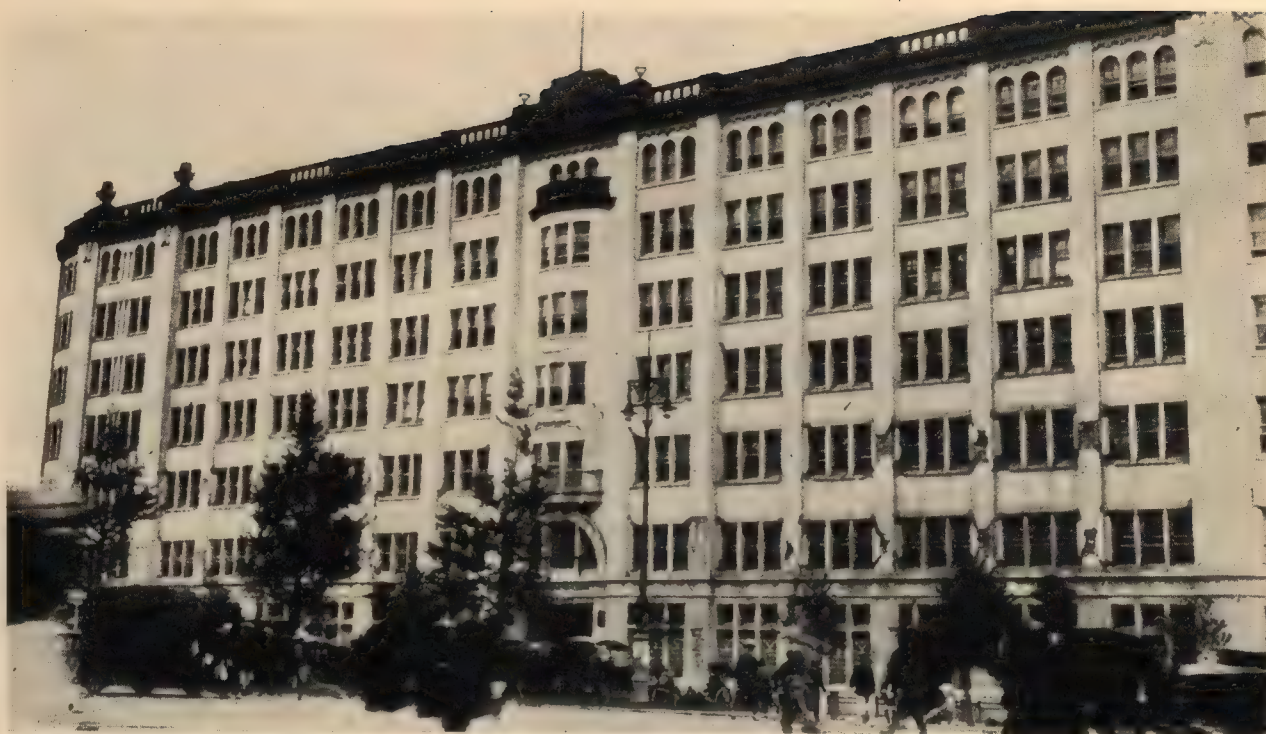
No. 34—Tokyo-Kaijo Insurance Bldg. Steel frame, brick walls, plaster exterior. Shortly after earthquake. Damage nominal.

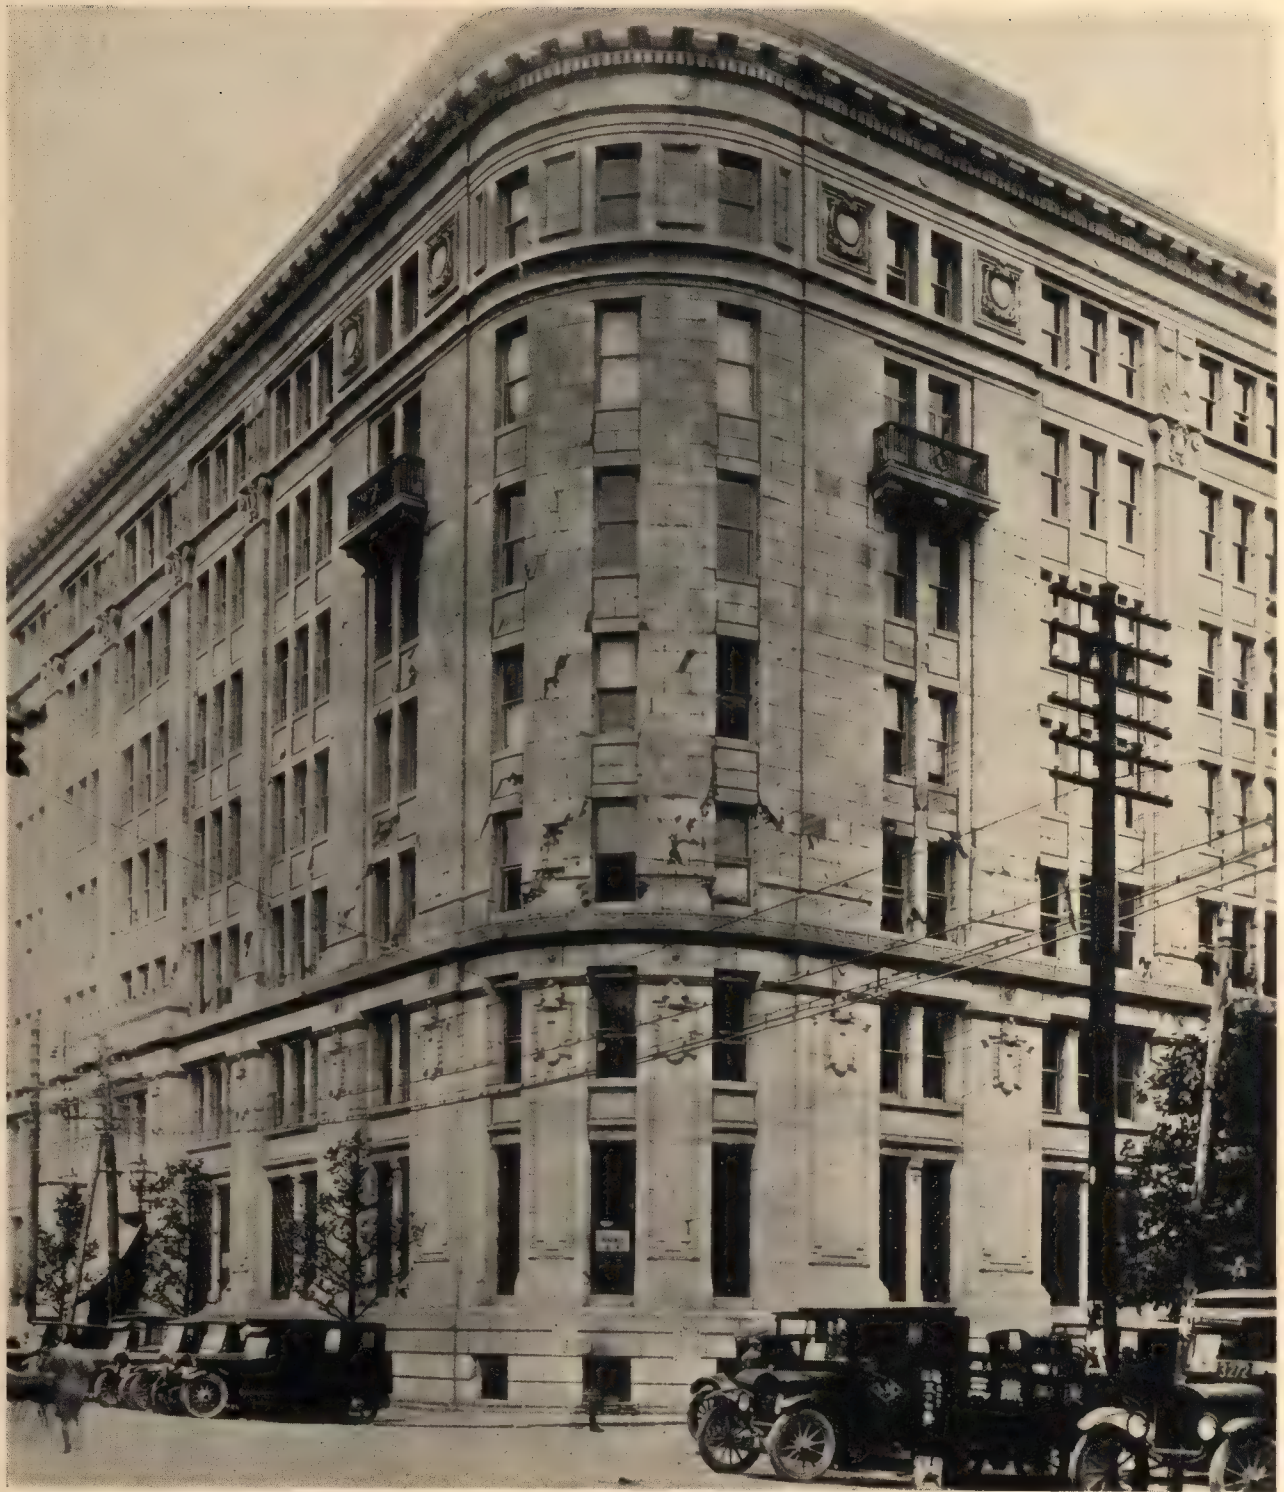
No. 35—Japan Oil Building. Steel frame, brick filler walls faced with terra cotta. Most of damage at curved street corner. Tenants never left building during repairs.

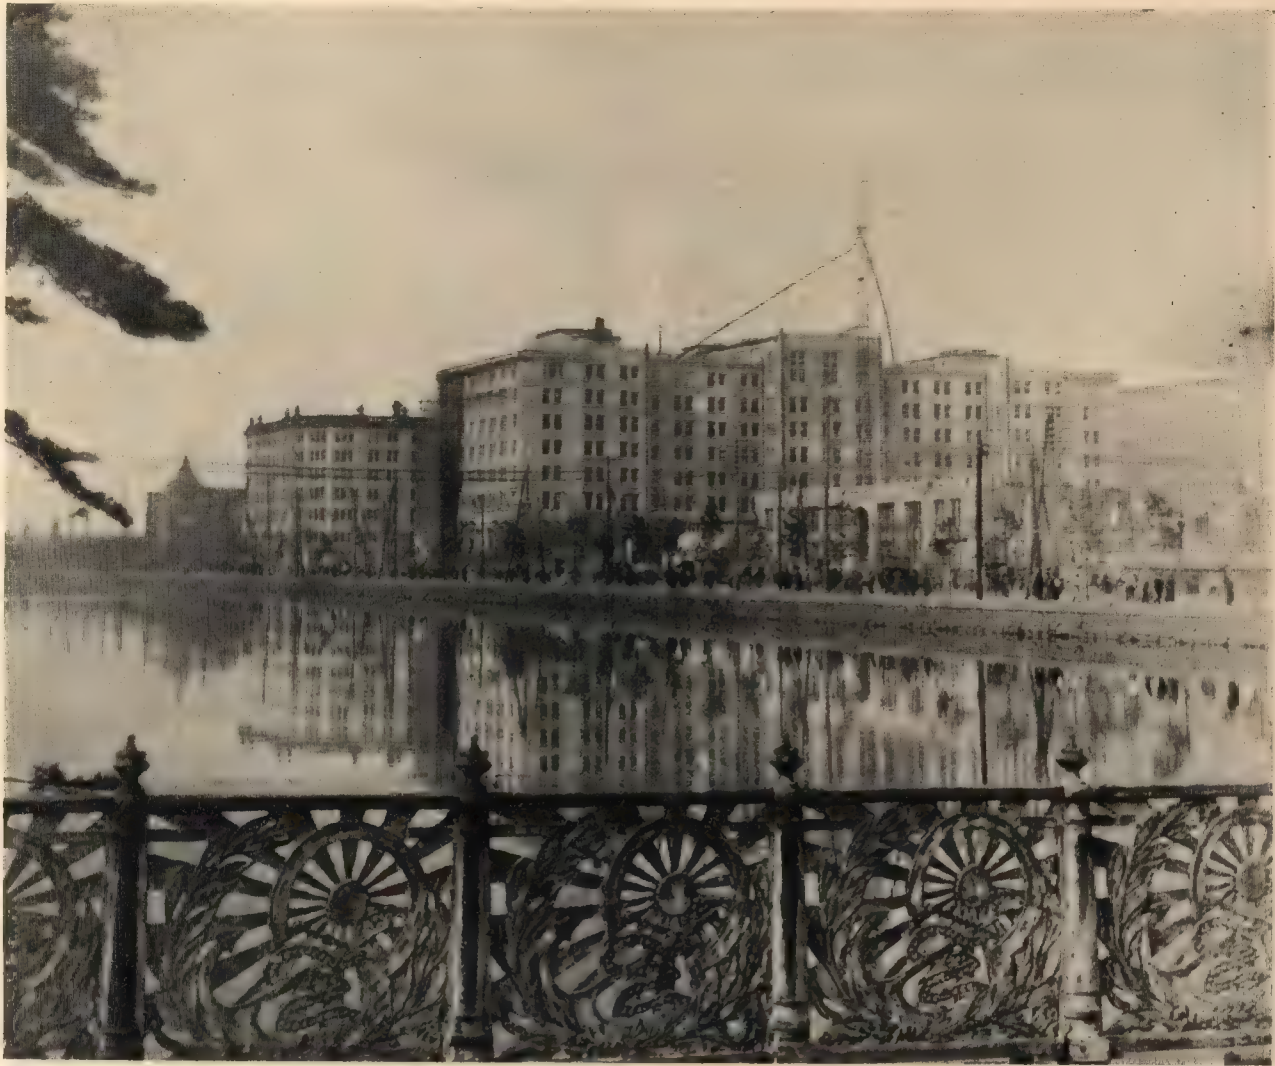
No. 36—View from bridge over Imperial Moat, Tokyo. N. Y. K. Building in center, Marunouchi Building extreme right, Tokyo-Kaijo Building left. All steel frame and brick filler wall structures. In center in front of N. Y. K. Building are ruins of 8-story Nagai reinforced concrete building which completely collapsed.

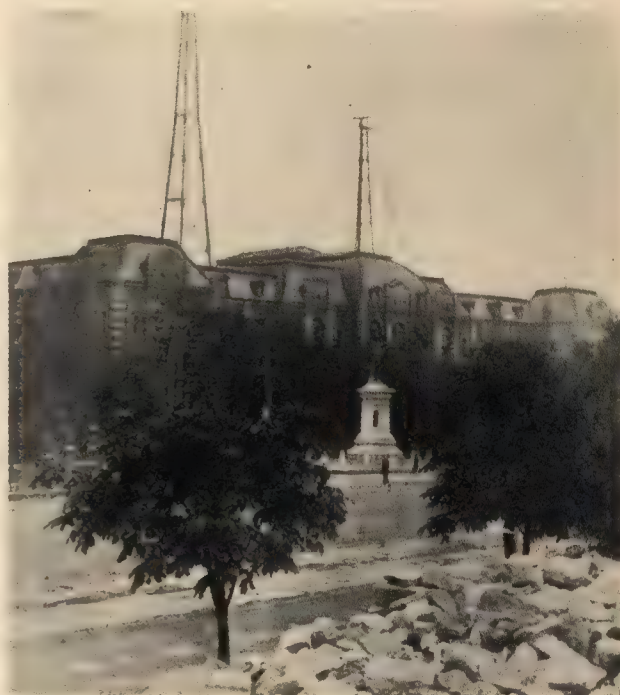
No. 42—Navy Department Building. Brick bearing wall construction undamaged by earthquake.

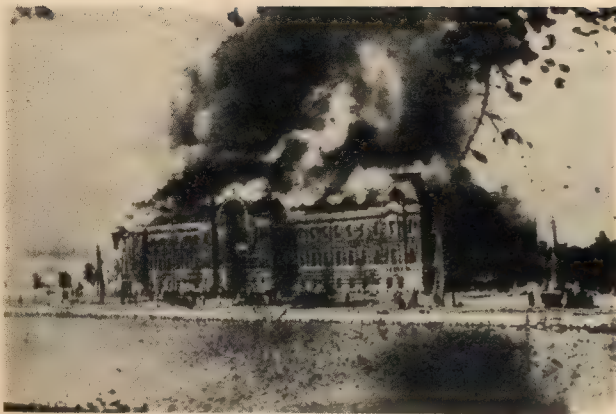
No. 43—Metropolitan Police Board Building burning during Toyko fire. Structure was unharmed by the earthquake and was constructed with brick bearing walls.

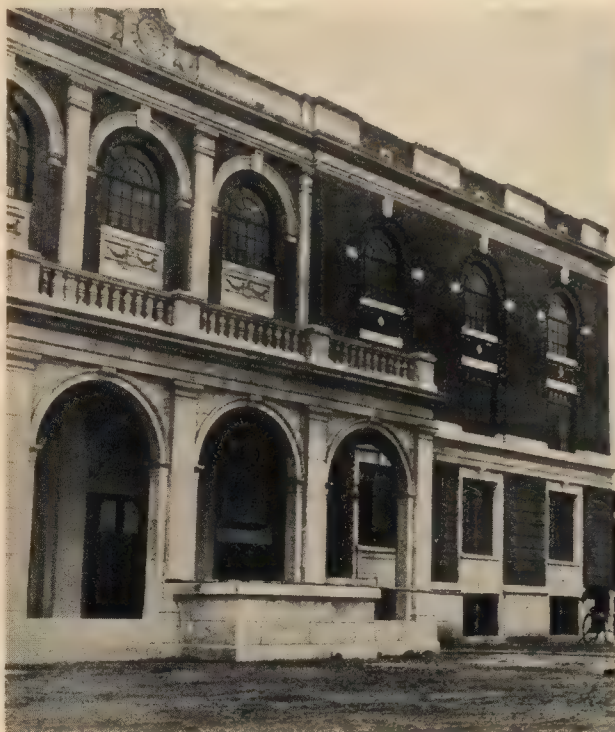
No. 45—Seiyukai Club, Marunouchi District, Tokyo. Brick bearing wall building undamaged by earthquake.

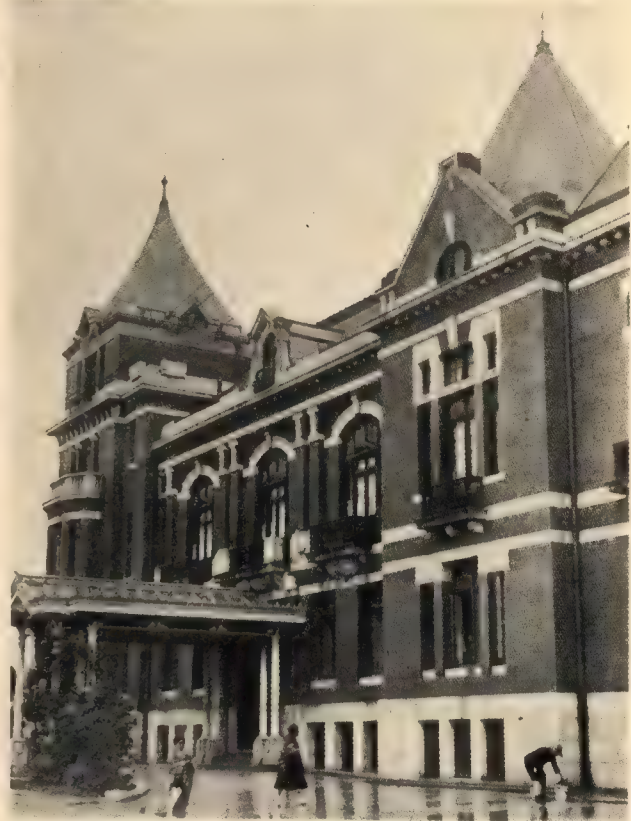
No. 44—Banker's Club, Marunouchi District, Tokyo. This bearing wall building survived the earthquake undamaged.

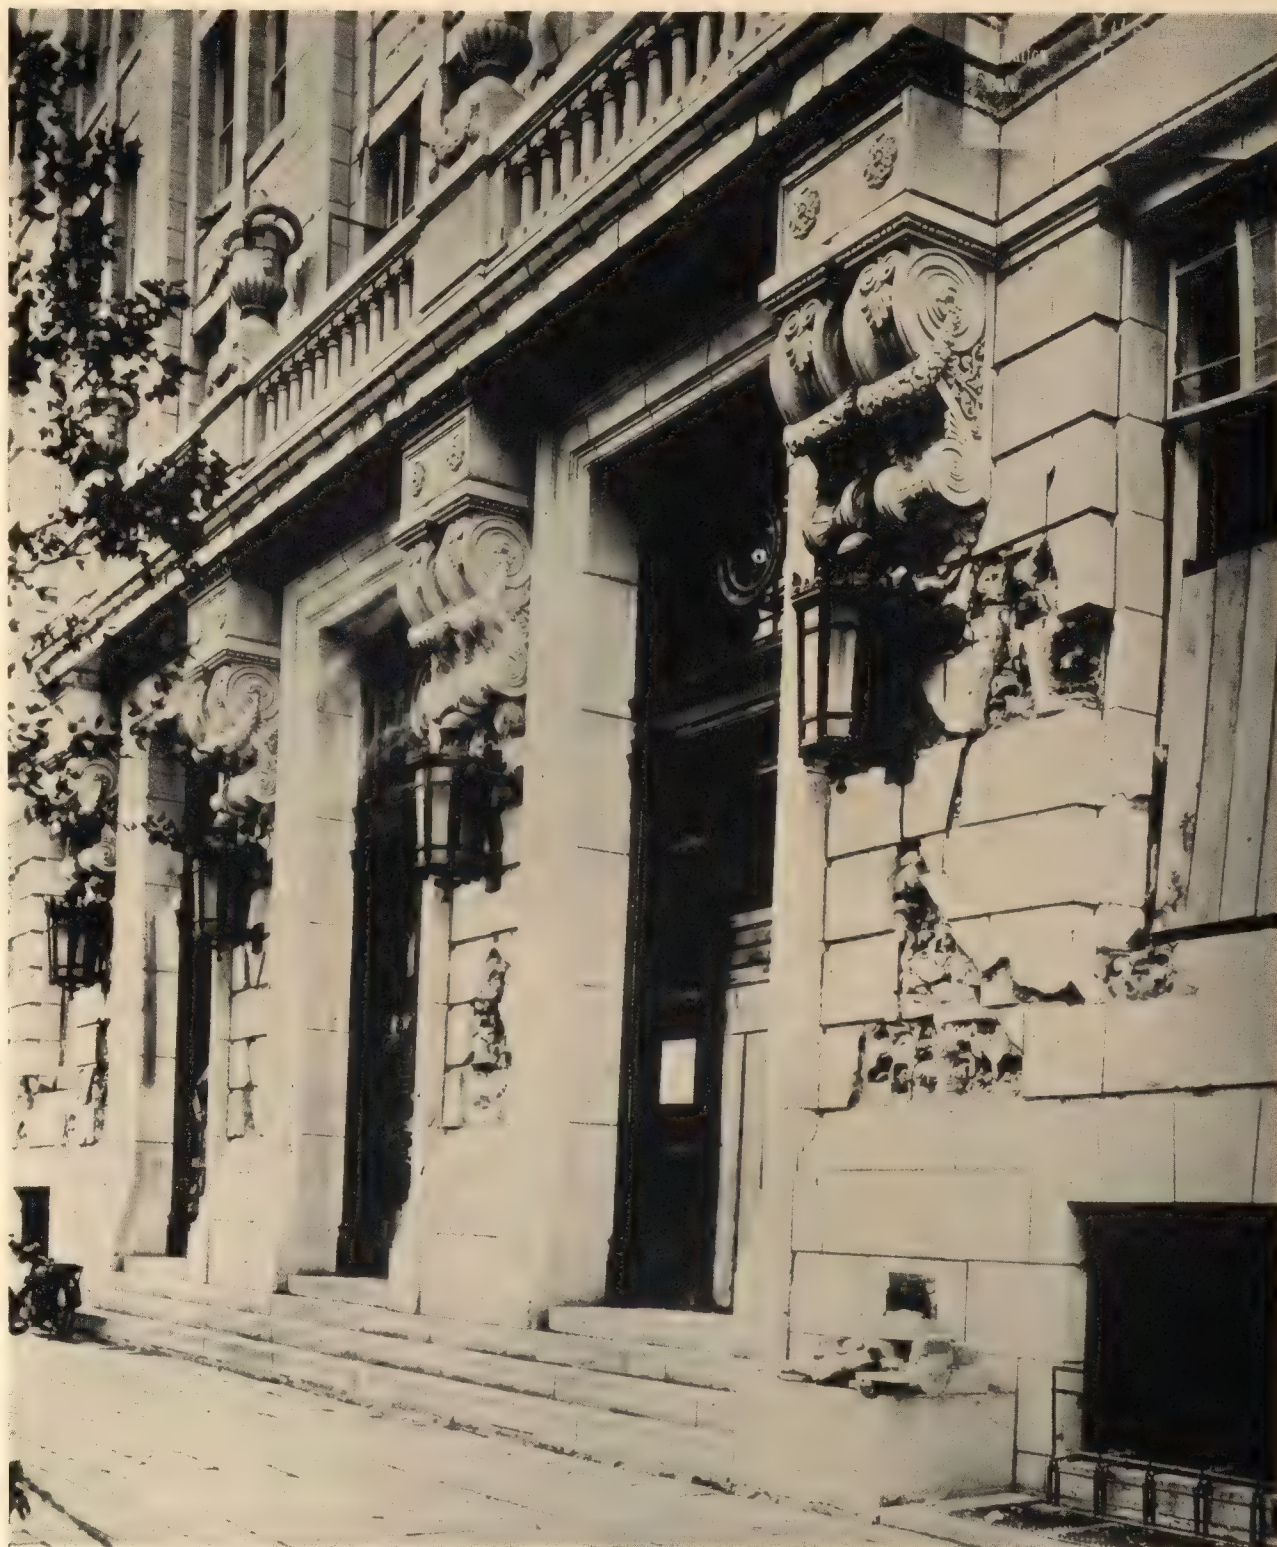
No. 46—Entrance of N. Y. K. Building, Tokyo. This shows damage to exterior terra cotta with the major ornamentation unharmed.

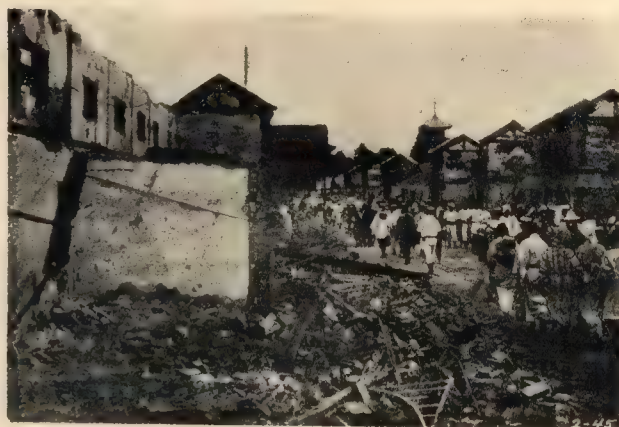
No. 47b—The same district after disaster. Note row of small brick buildings at right of street unharmed by the earthquake or fire.

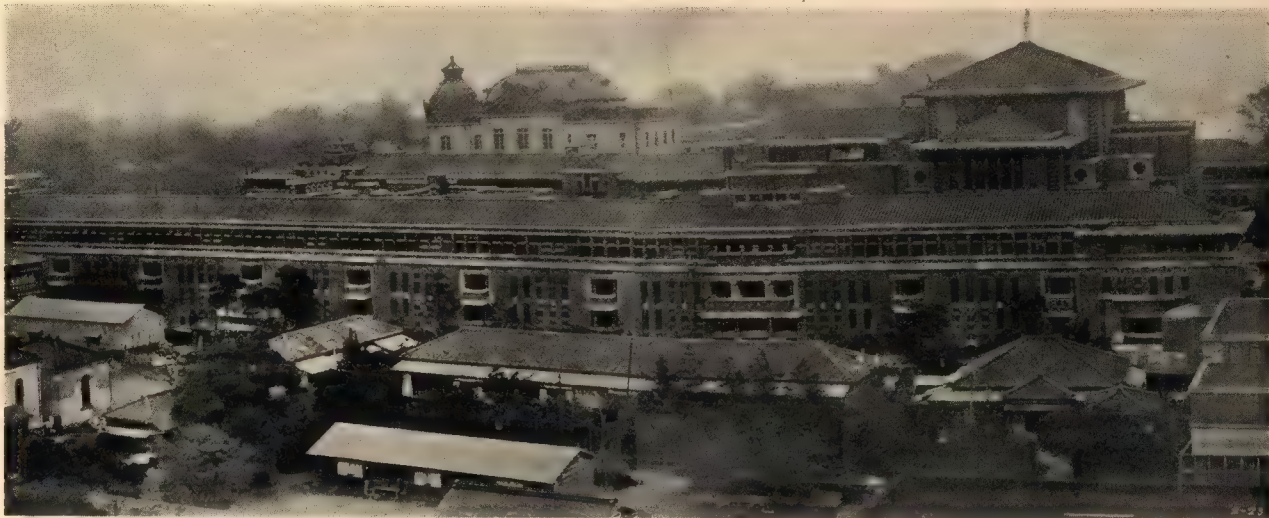
No. 48—Imperial Hotel. Reinforced concrete frame, brick facing. This building was undamaged. Note also brick bearing wall building seen over the roof of the hotel occupied by a life insurance company. This was also undamaged.

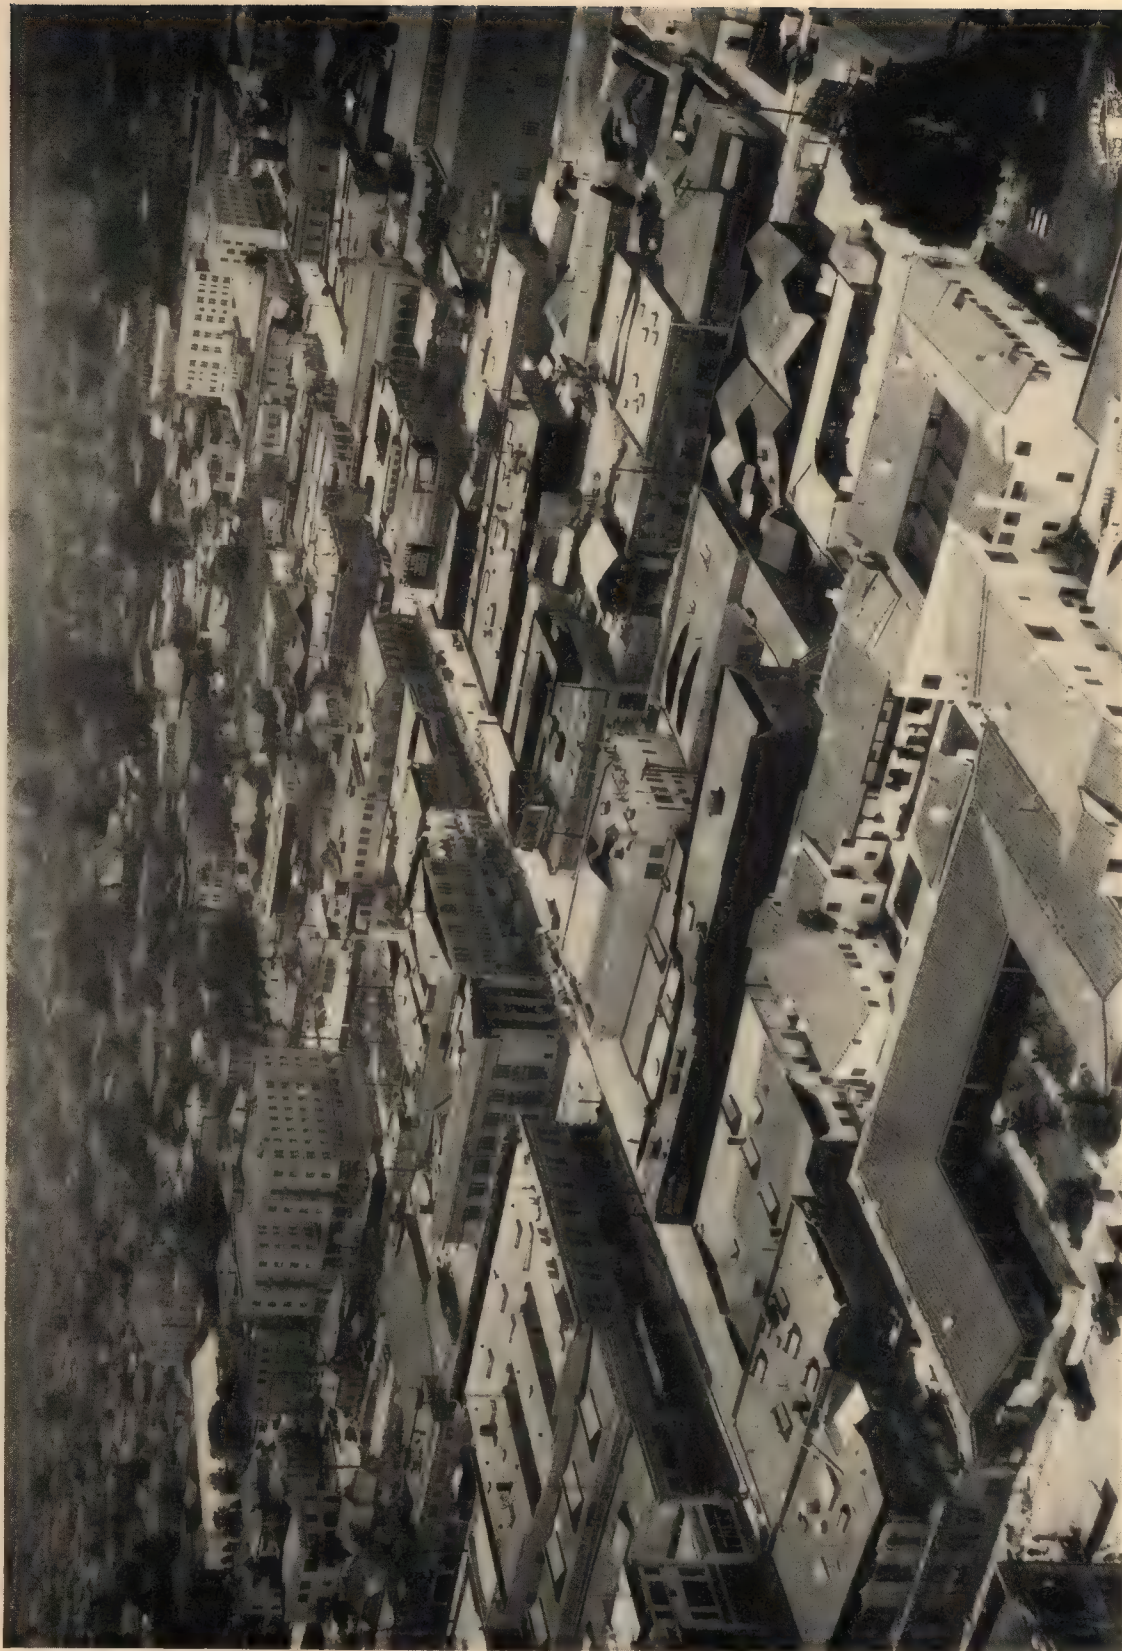
No. 56—Santa Barbara immediately after the earthquake. Note comparatively small damage. Also that most of the chimneys, which were all of brick, are standing. For detailed discussion see pages 52 and 89.

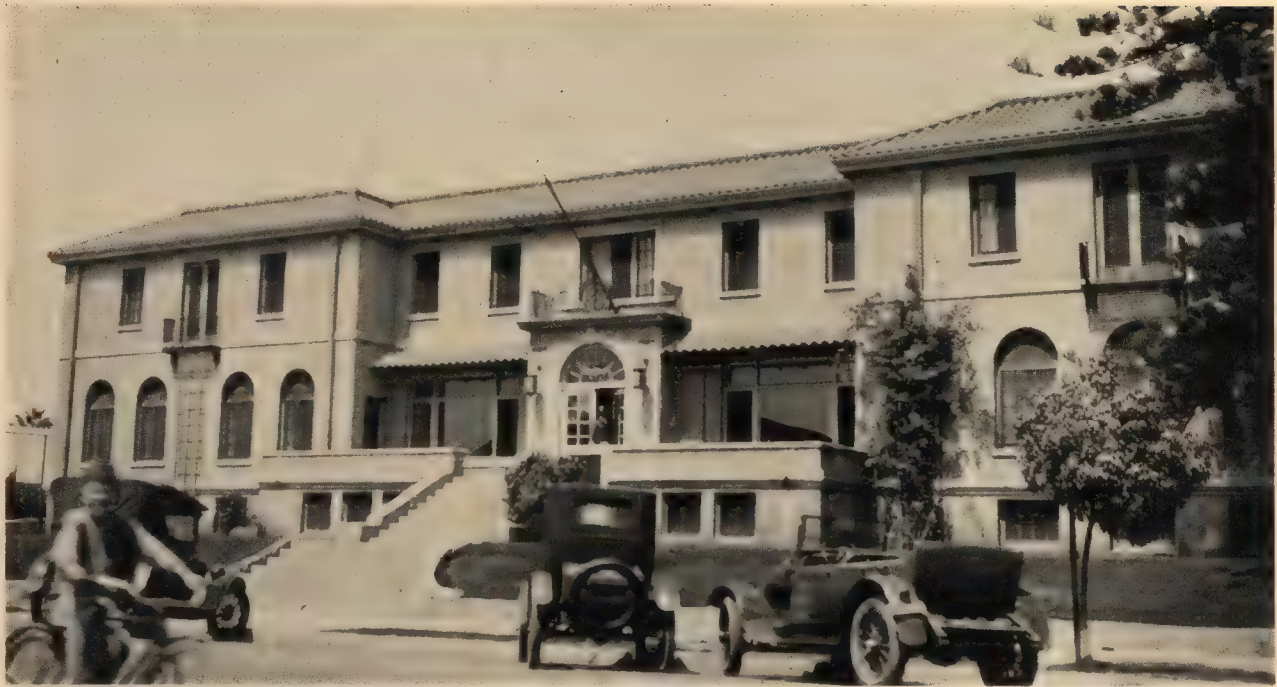
No. 57—An example of standard brick building unharmed by earthquake. The Santa Barbara Y. M. C. A.

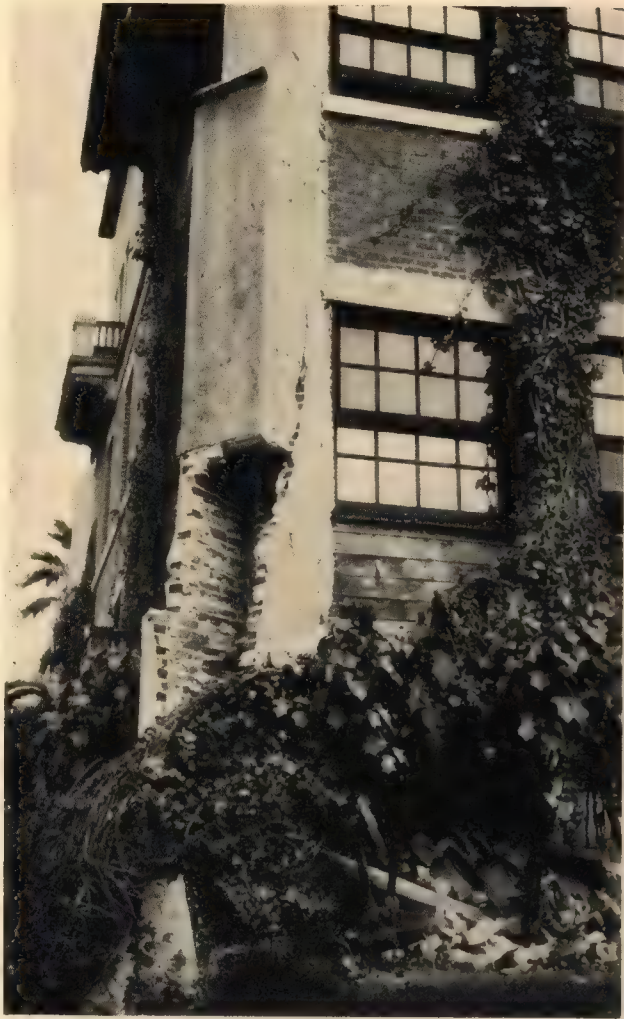
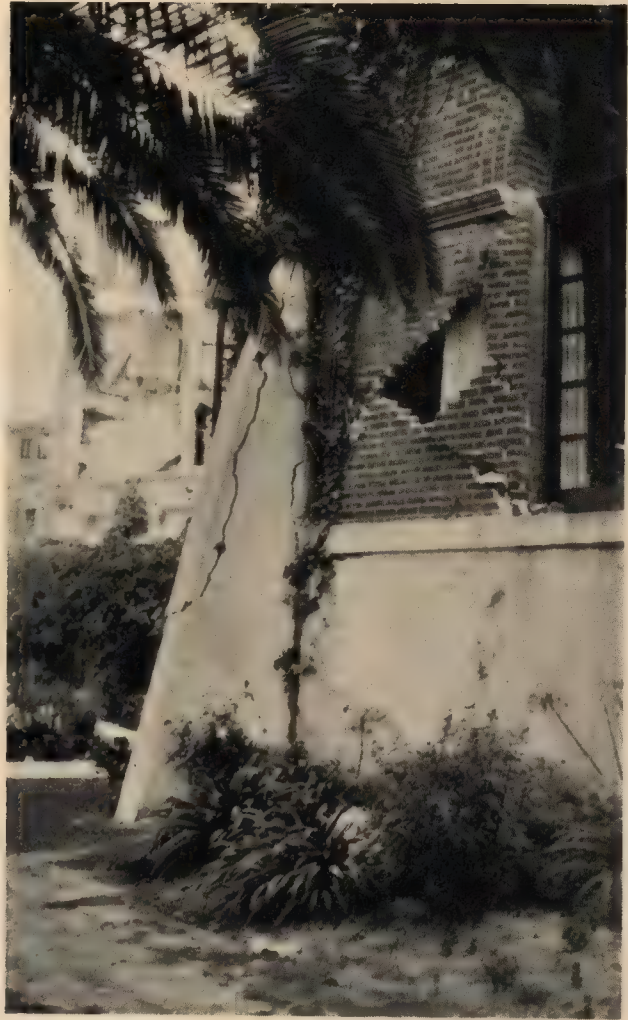
Nos. 58 and 59—The earthquake shows up false construction. Hollow buttresses and 4-inch brick wall with nothing to bond into in the Arlington Hotel. Note the reinforced concrete column in No. 59.

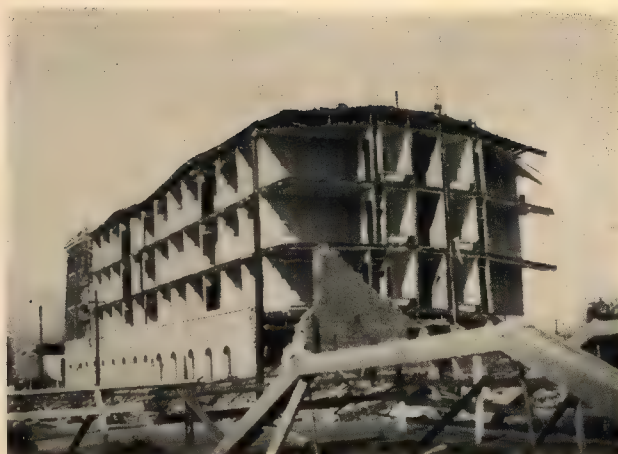
No. 63—*Californian Hotel*. Building was located on marshy ground. Walls inadequately tied and bonded were battered by movement of interior frame. This building was completely restored by the use of exterior steel frame at a total of about 40% of the original cost.

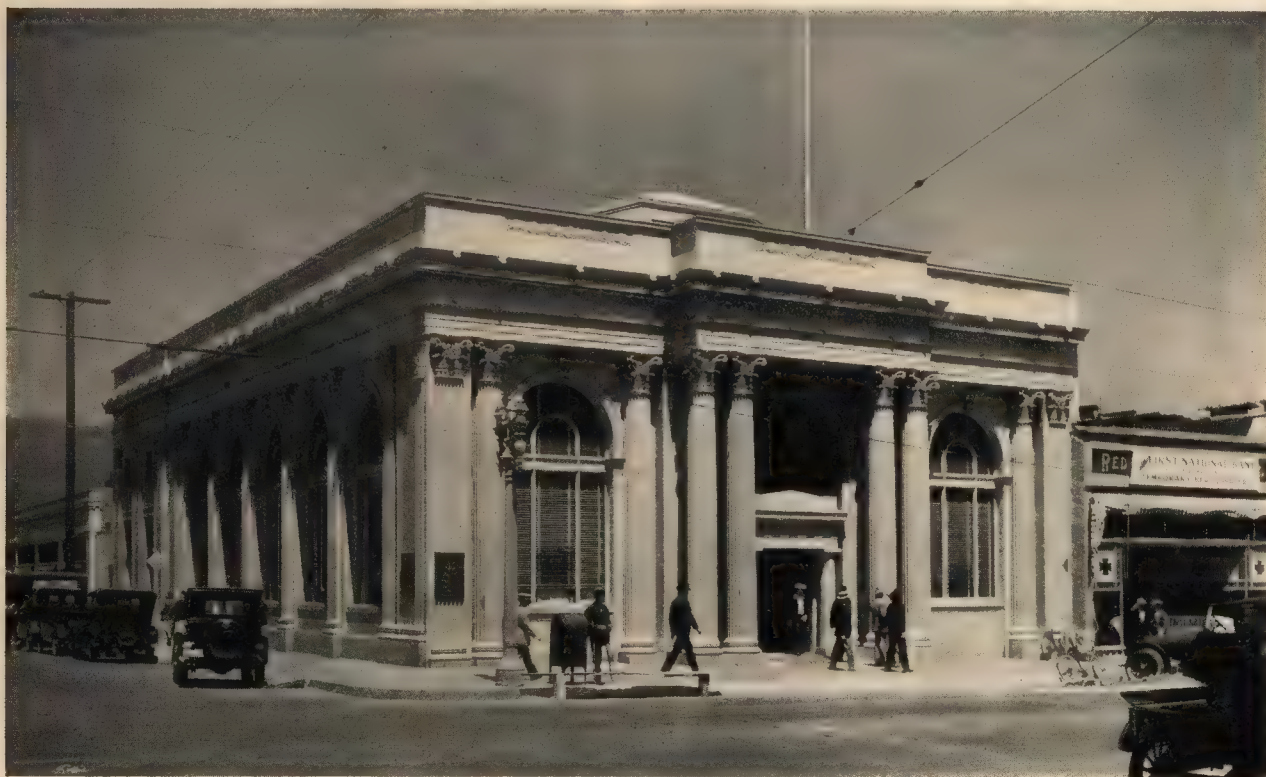
No. 64—*Pacific Southwest Bank, formerly Commercial Trust & Savings Building*. Common brick walls, terra cotta facing. Entirely unharmed, with the exception of small crack in one rear wall.

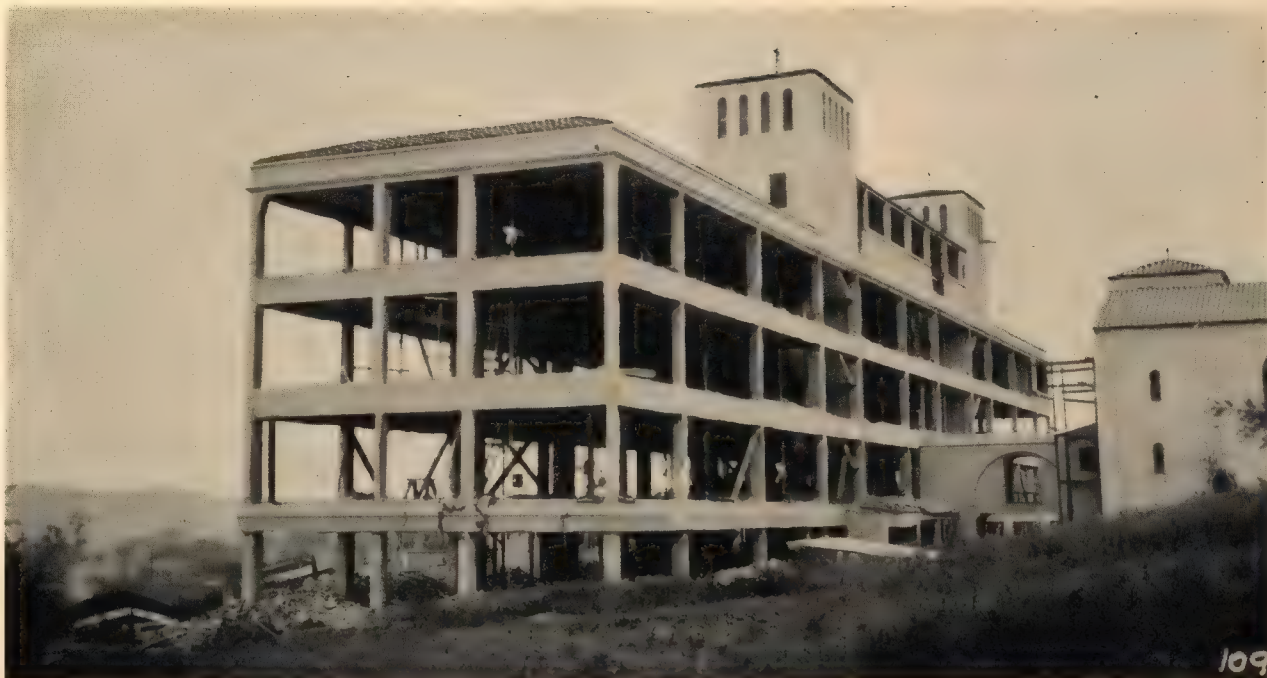
No. 65—Saint Francis' Hospital and Chapel after damaged filler walls and partitions had been removed. Hospital building of reinforced concrete had to be entirely demolished. It had partition tile filler walls, but the concrete frame was shattered beyond repair. The small building in the corner is a Chapel with brick bearing walls which was substantially unharmed.

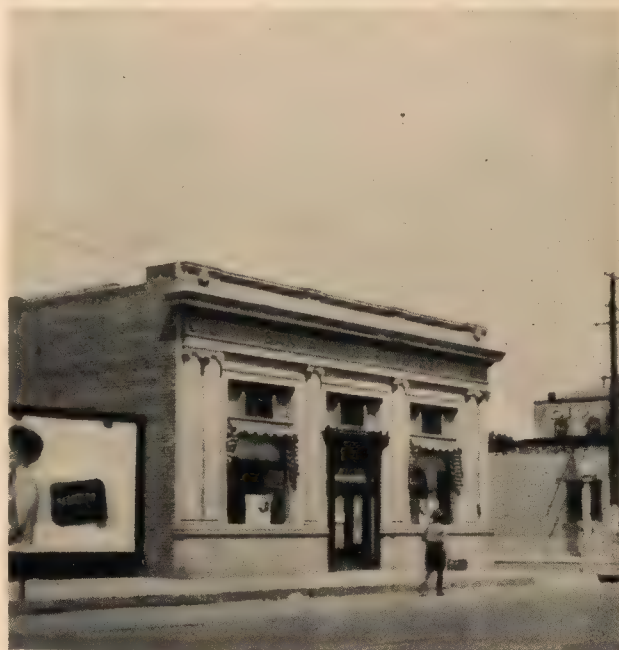
No. 66—Banca-Populare-Fugazi. Brick bearing wall, terra cotta facing. Unharmed.

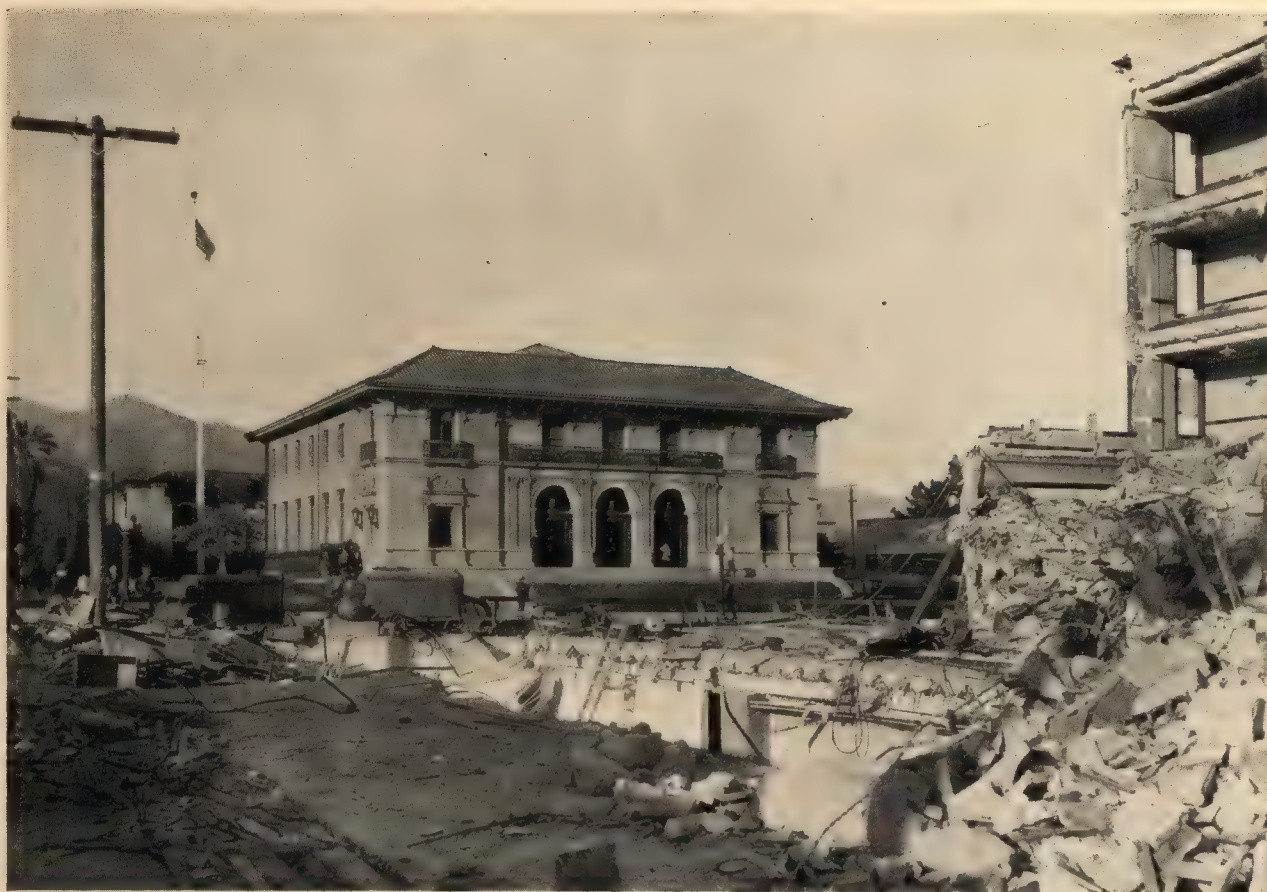
No. 67—The Post Office seen over the ruins of the reinforced concrete San Marcos Building. The Post Office is a brick bearing wall building with interior floor loads carried by light steel frame, was unharmed except for small crack shown in left hand corner. Neither tile roof nor interior was damaged.

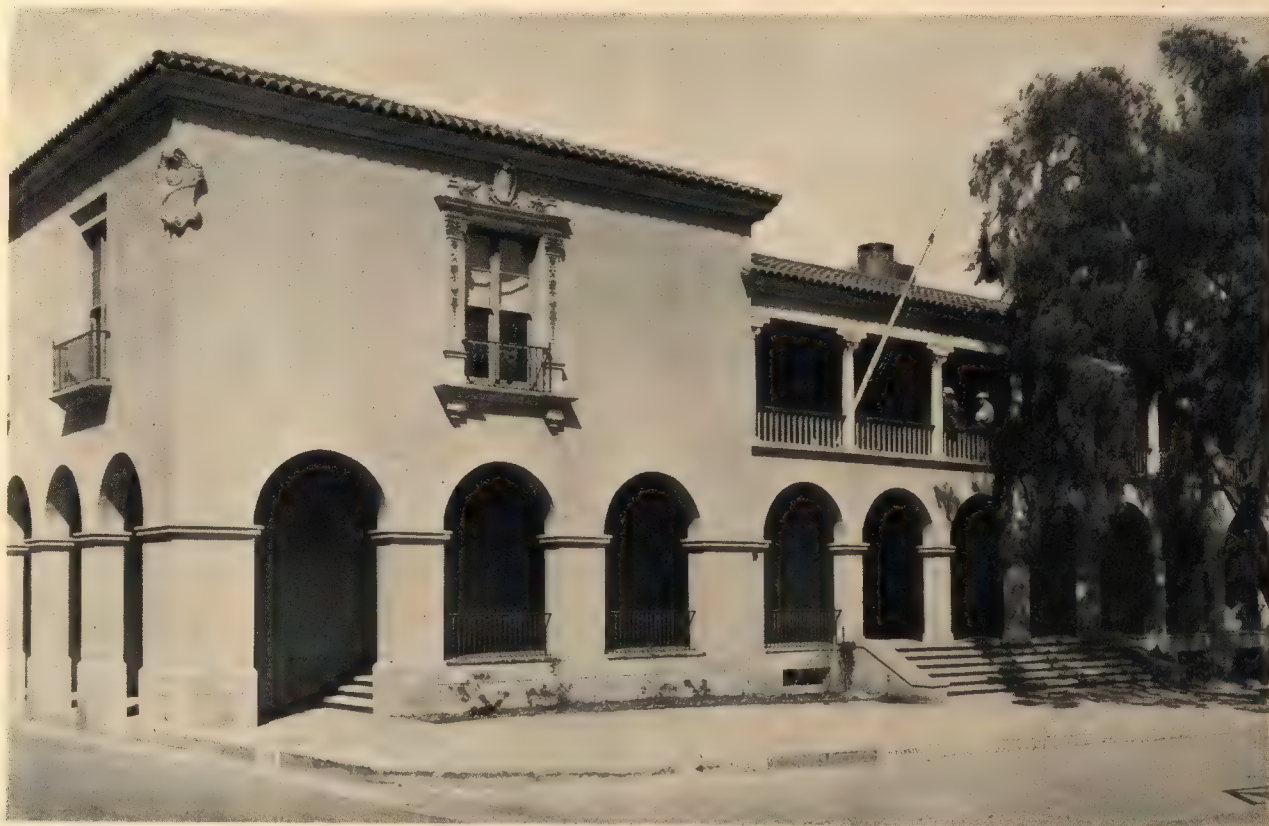
No. 68—City Hall, Santa Barbara. Another example of the unharmed brick bearing wall building with tile roof. This building had interior concrete frame for floor loads only.

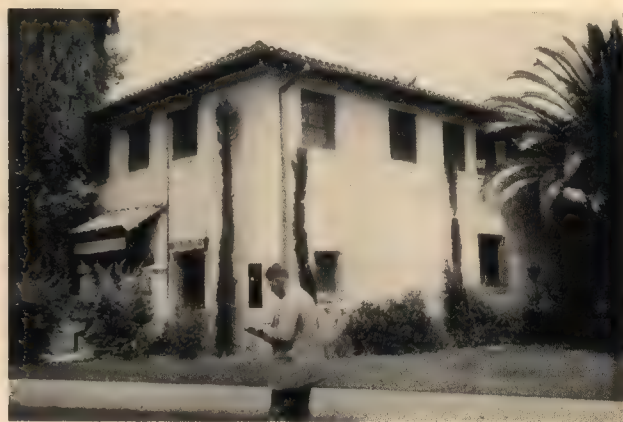
No. 73—Brick bearing wall building on the Hotel Arlington grounds occupied by I. Magnin & Company. Building was unharmed, with the exception of small plaster crack.

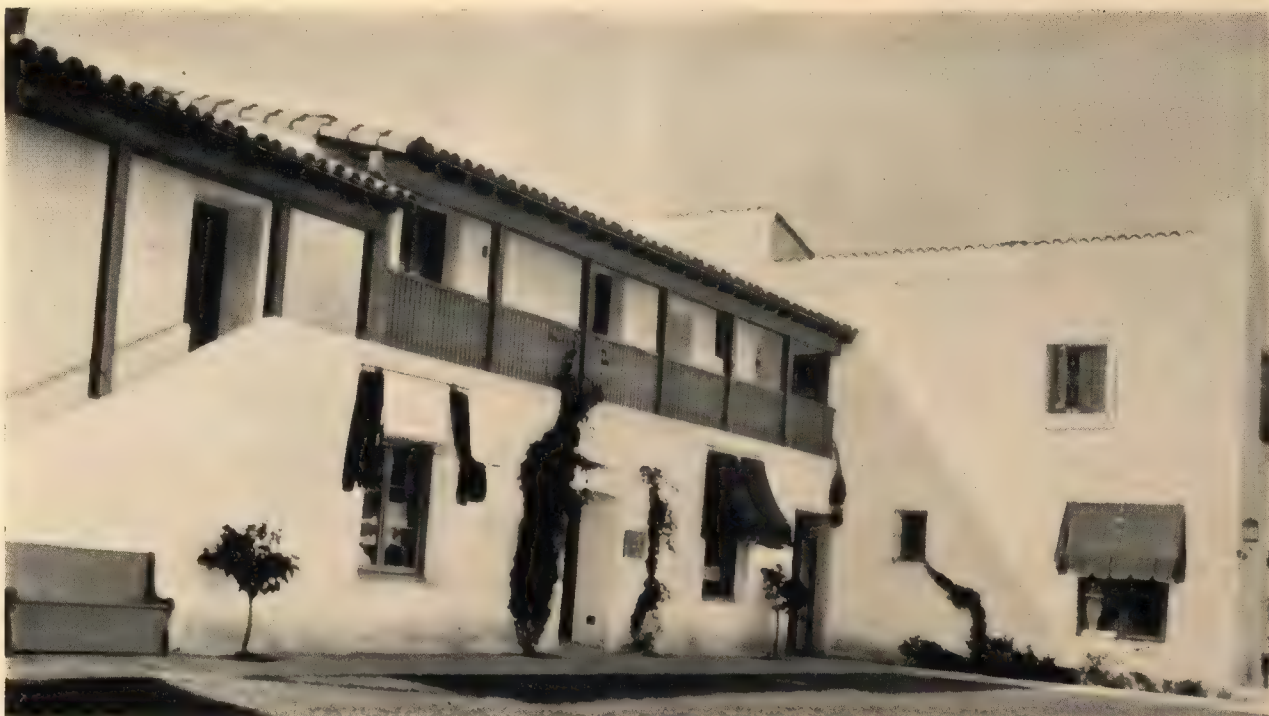
No. 75—El Paseo Court immediately following earthquake. Bearing wall structure of load bearing hollow clay tile entirely undamaged.
